PEMBROKE DAM

NH 00377

PHASE I INSPECTION REPORT
NATIONAL DAM INSPECTION PROGRAM

MARCH 1979

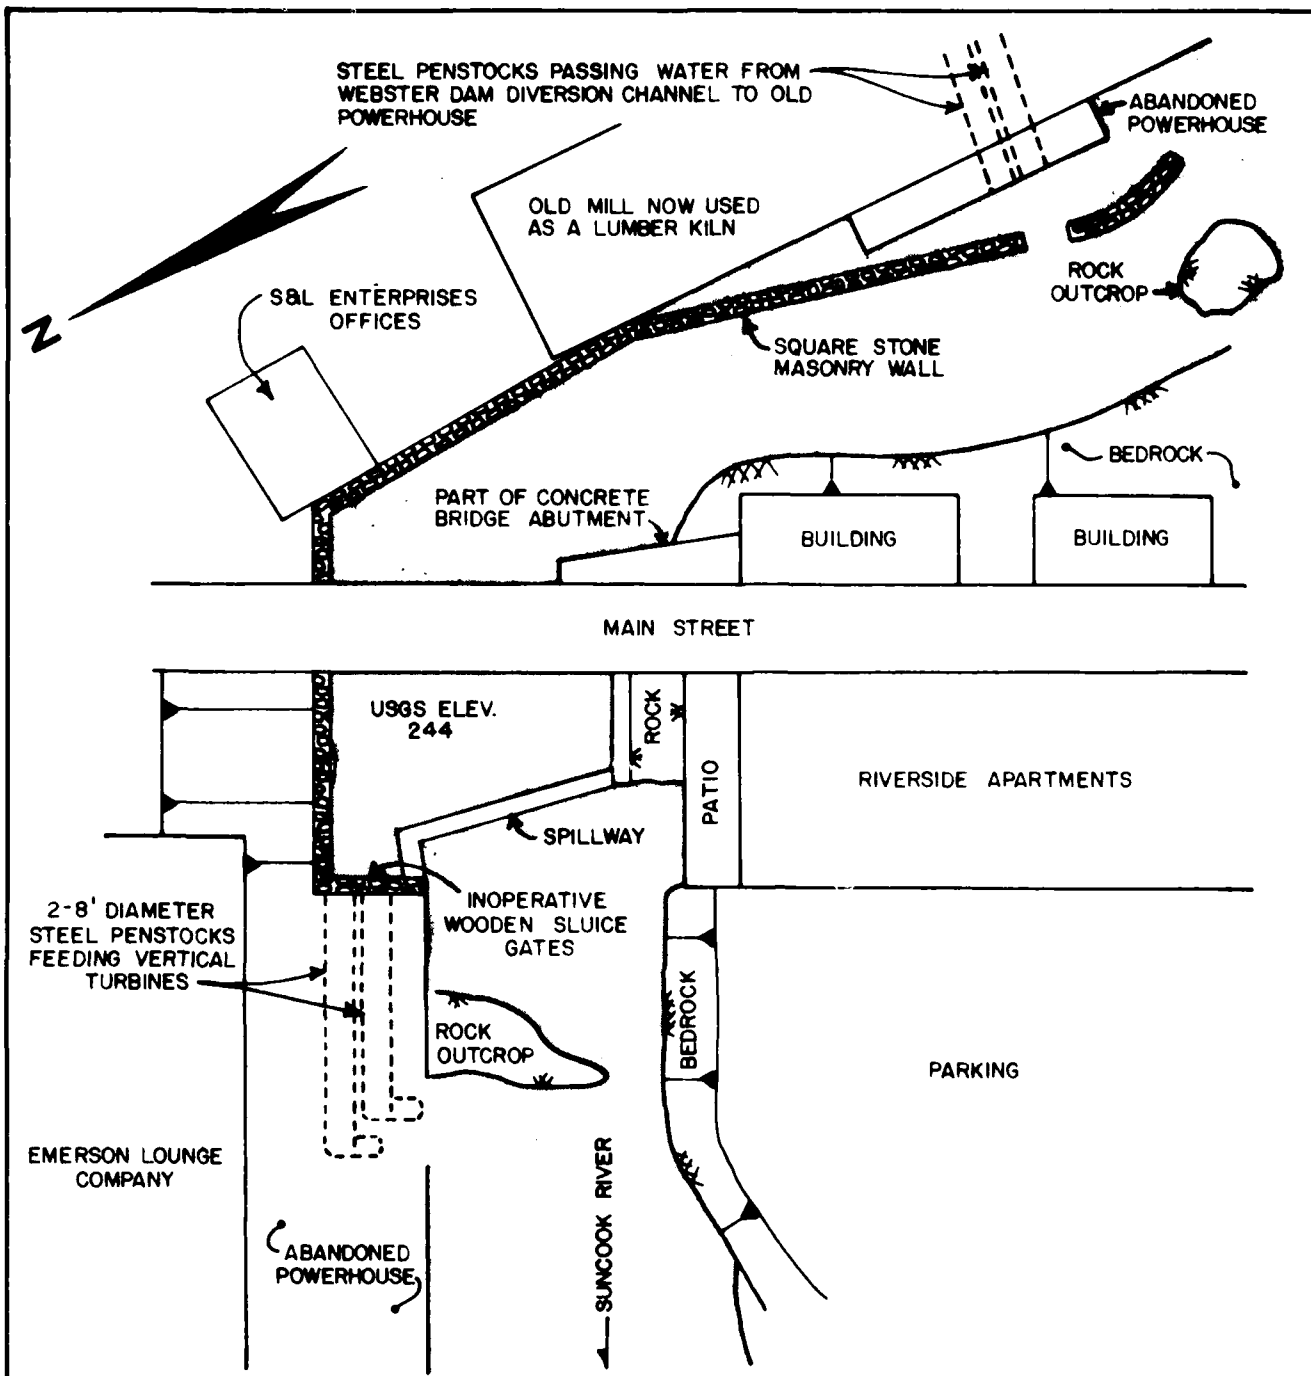
FIGURE 1 SITE PLAN

Pembroke Dam lies on the Suncook River and crosses the town lines of Pembroke and Allenstown, N.H. The dam is about 50 feet downstream from where the Main Street Bridge crosses the Suncook River and is about 0.6 miles upstream from the confluence of the Suncook and Merrimack Rivers. The portion of the USGS Suncook, N.H. quadrangle presented previously shows this locus. Figure 1 of Appendix B presents a detail of the site developed from the inspection visit and the quadrangle map.

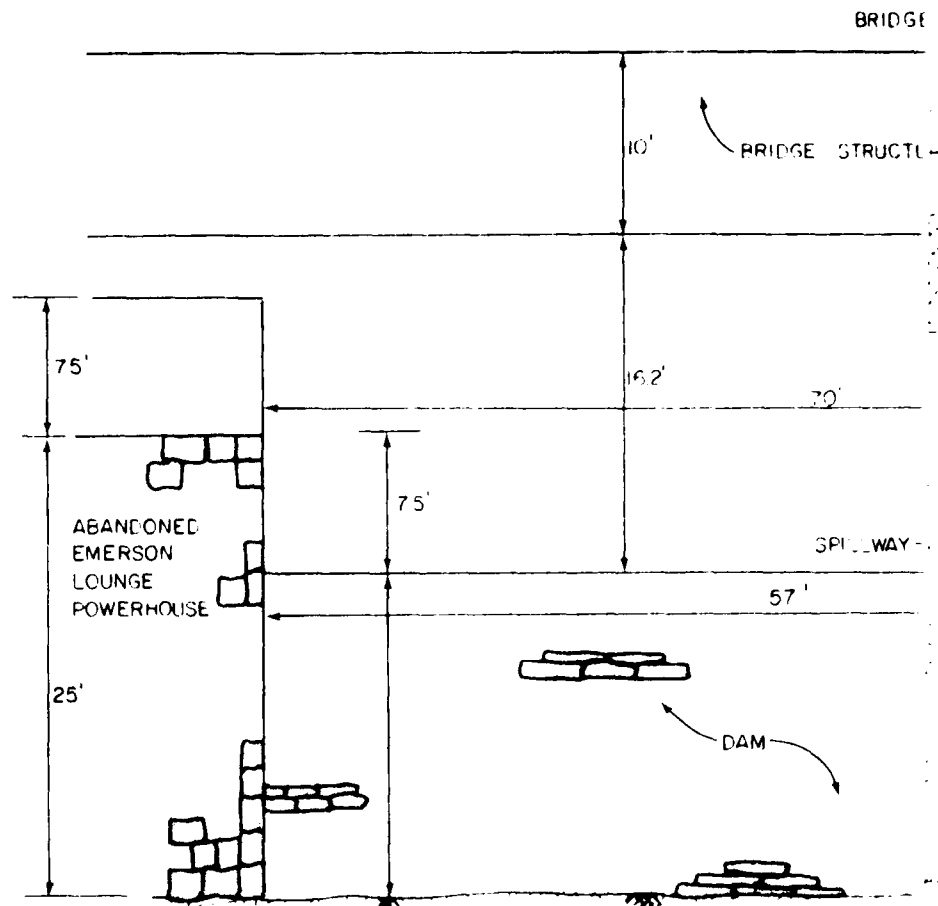
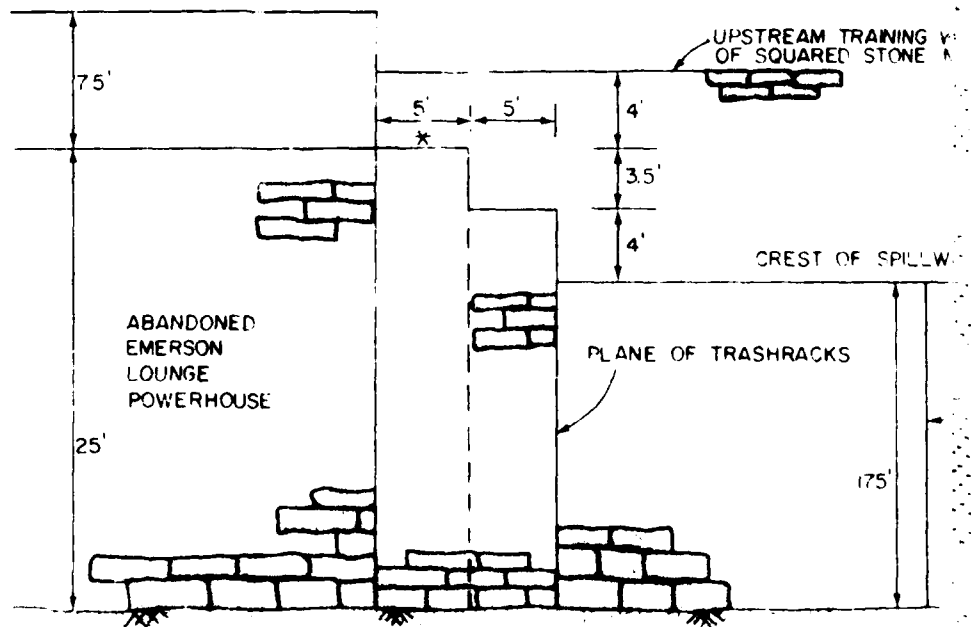
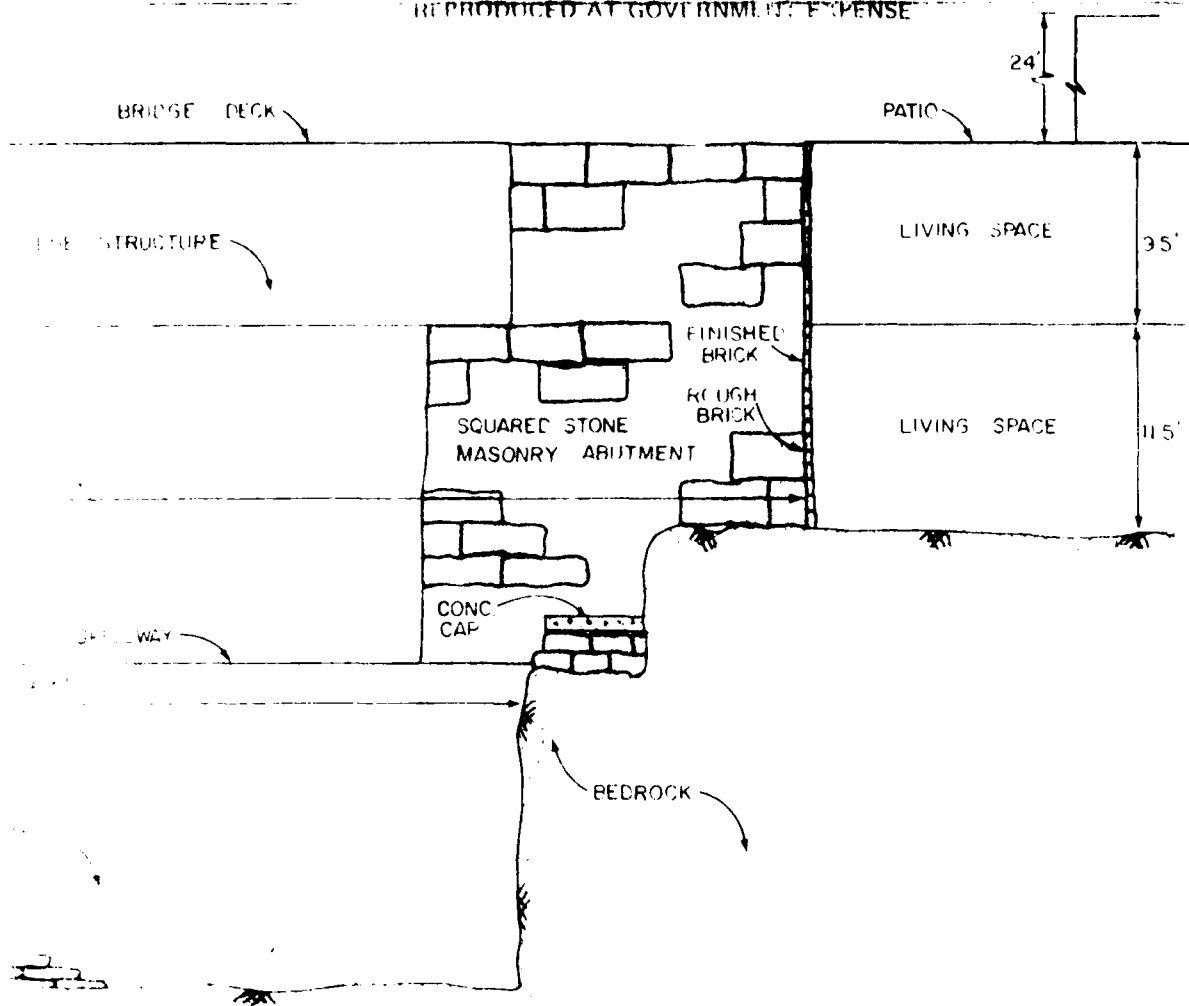
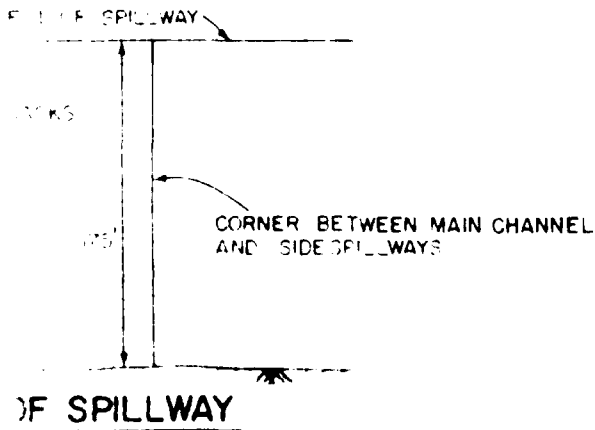
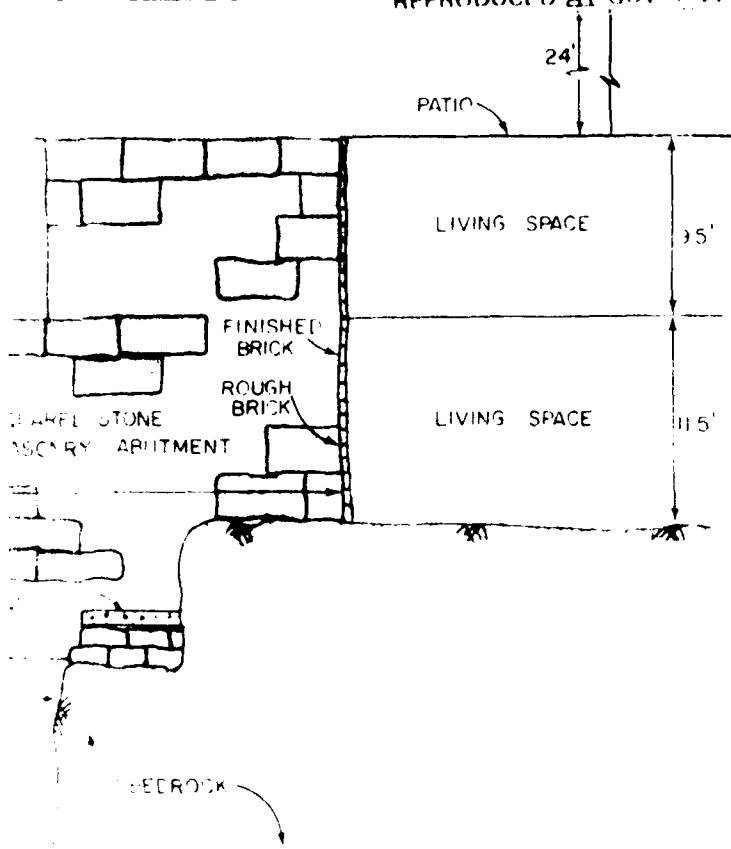
NATIONAL PROGRAM OF INSPECTION OF NON-FED
FIGURE 3
ELEVATION VIEWS

* HIGH WATER 2 yrs AGO
HIGHEST IN 32 yrs ±

DAM TRAINING WALL
SQUARED STONE MASONRY

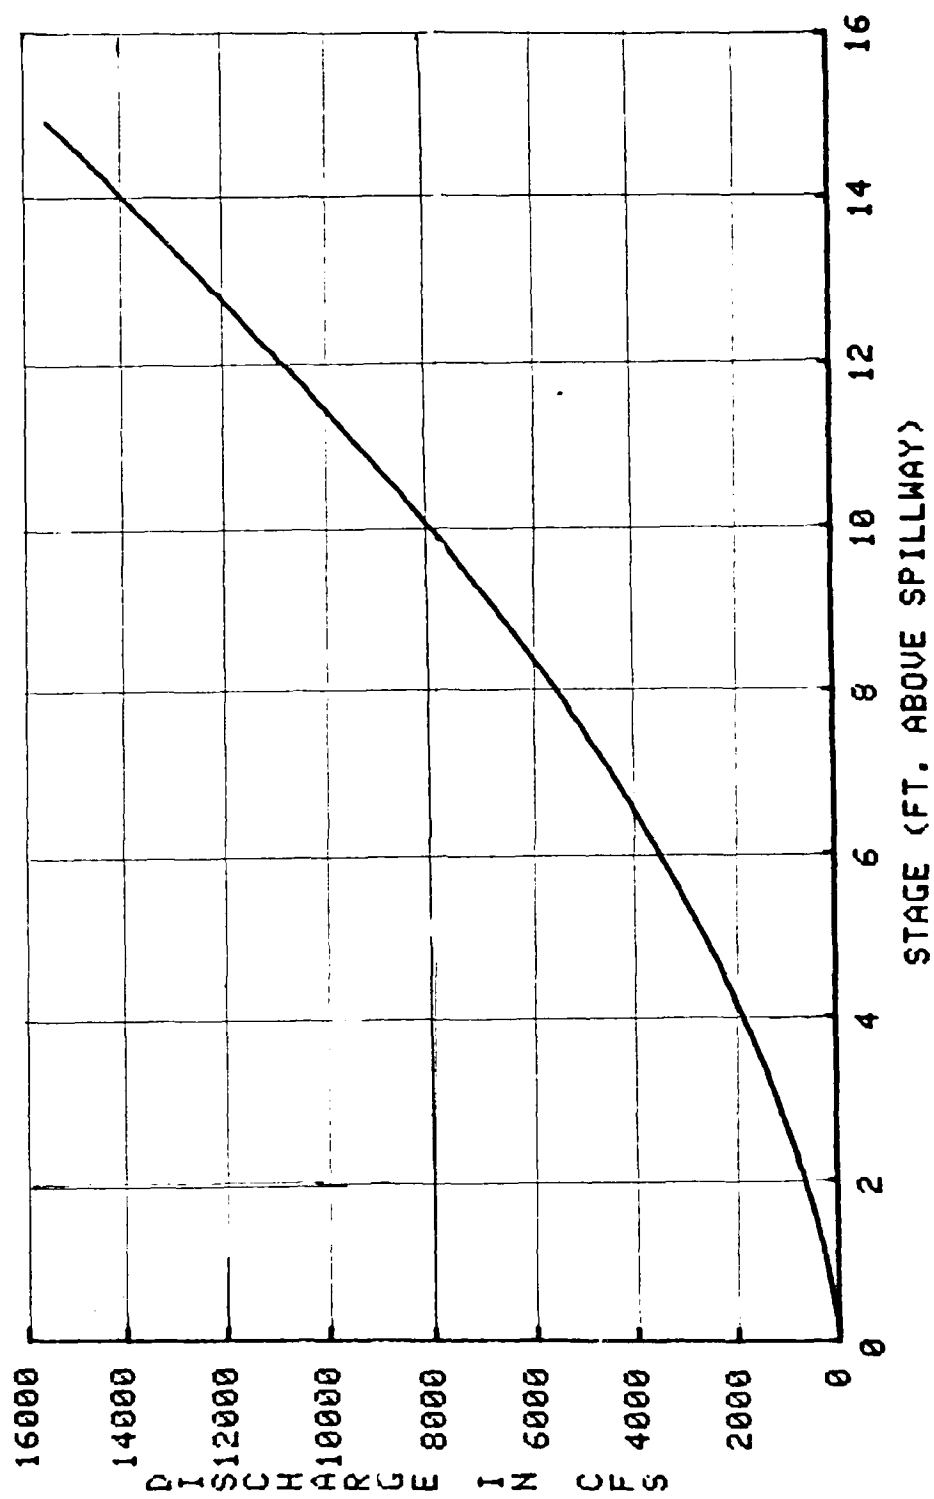
STAGE-DISCHARGE CURVE AT PEMBROKE DAM

The discharge prior to failure with the water level at the top of the lower abutment, 4.0 feet above the spillway, would be 1850 cfs as determined from the Stage-Discharge curve developed and shown in Appendix D. This flow is significantly less than ANCO's estimated 10-year flow of 6990 cfs. The tailwater prior to failure would be 233.4 feet MSL, 10.7 feet below the spillway.

Assume that the dam fails when the water surface elevation reaches the abutments, at $h=4.0$ (elevation 248.1). From the stage-discharge curve, this would require a discharge of 1850 cfs. The tailwater elevation curve indicates that this flow would create a tailwater elevation of about 233.4' MSL (linear extrapolation)

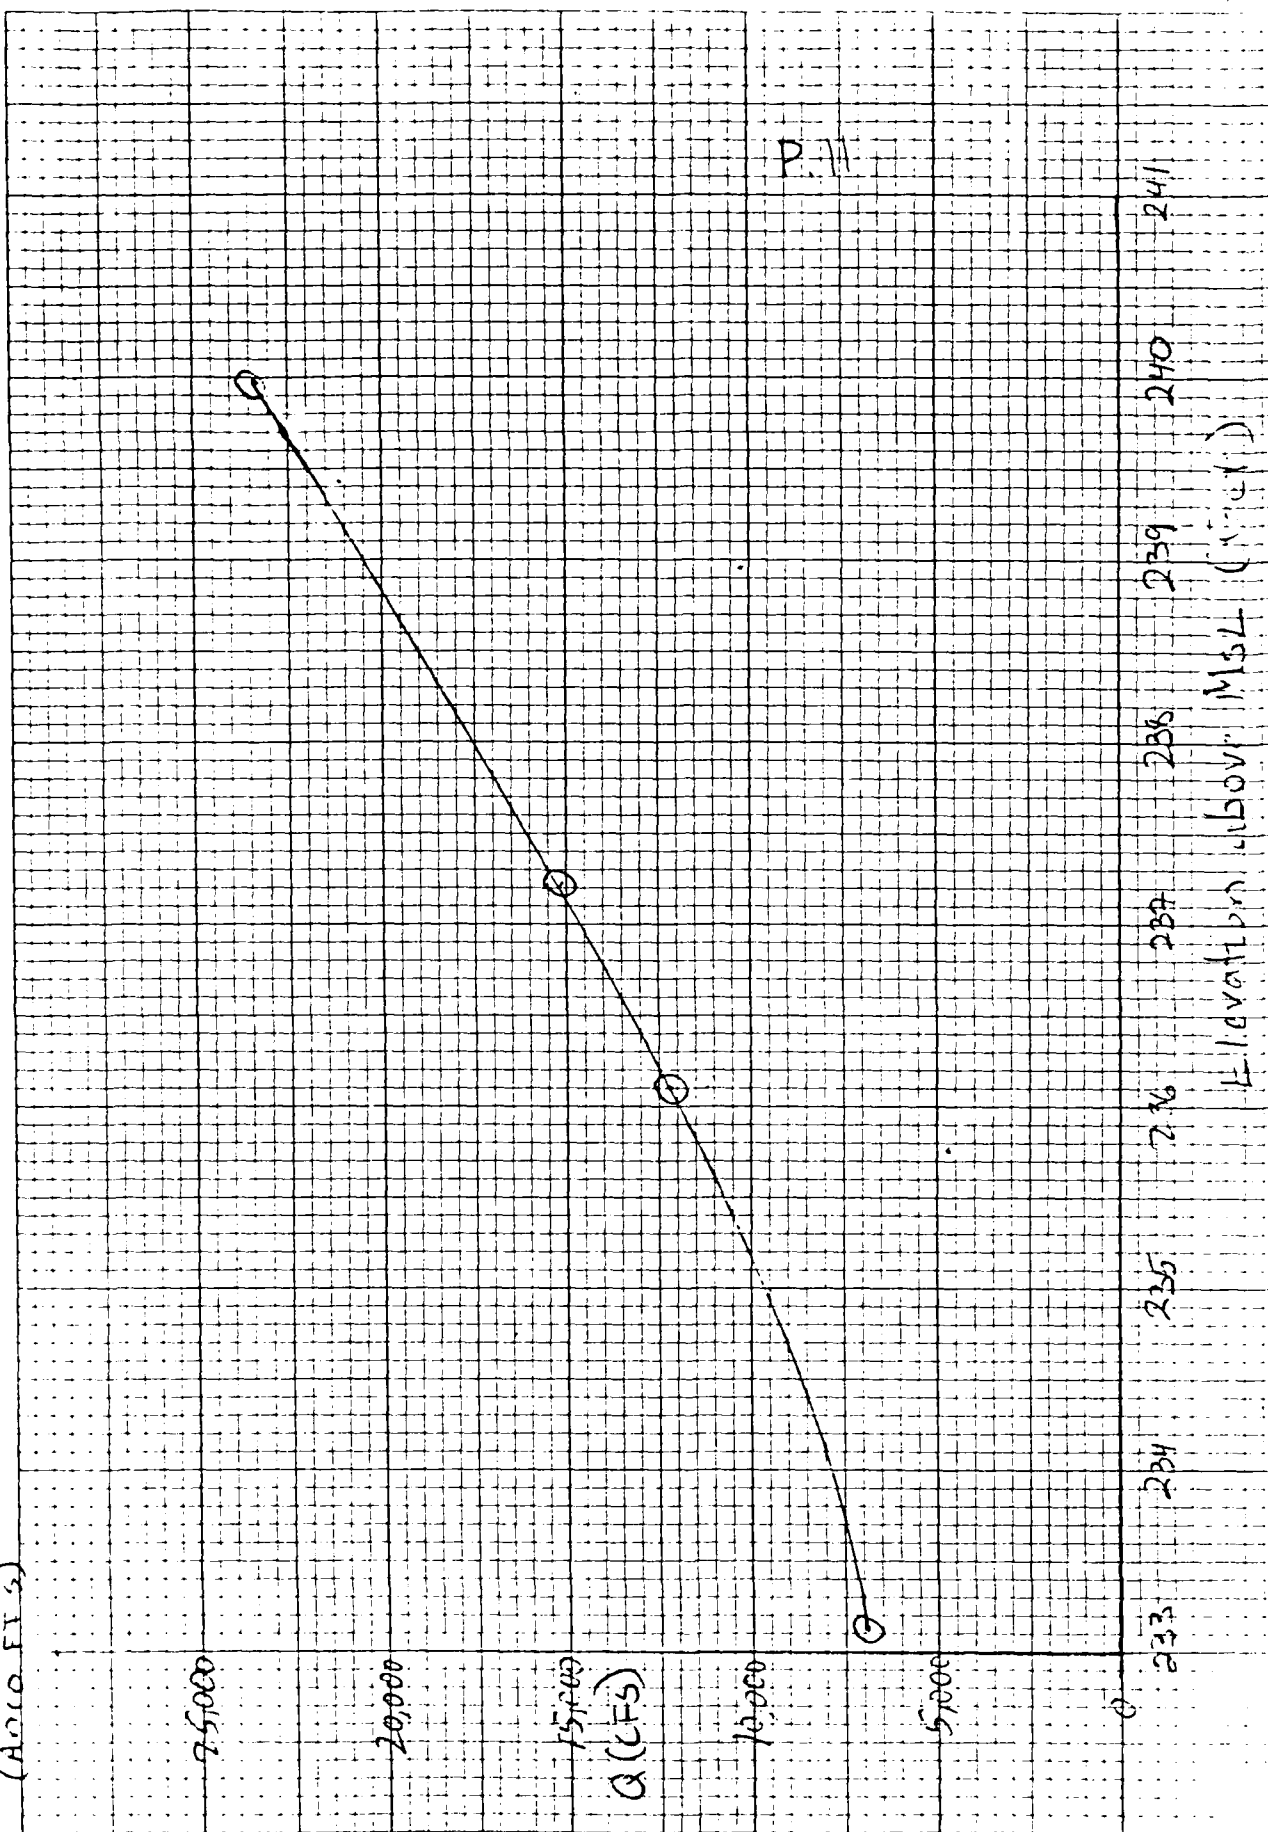
Discharge-Elevation Curve 650' Downstream of Pembroke Dam
(AFCO FTS)

The 1st downstream location which might be affected by dam failure is a group of houses 650' downstream of the dam at 216' MSL. The Discharge-Elevation curve for the Suncook River at these houses is shown on p. 11. Note that the lowest discharge shown, 7000 cfs, requires a water surface elevation of 233.2' MSL - the peak failure outflow of 4690 cfs should generate a water surface below this, and well below the houses.
